FINAL RANDOM INSPECTION

COMPRESSION SOFAS

Pre-shipment quality inspection report

MODEL SB-B-COMP-LZSF-BR · 5 PCS SAMPLED

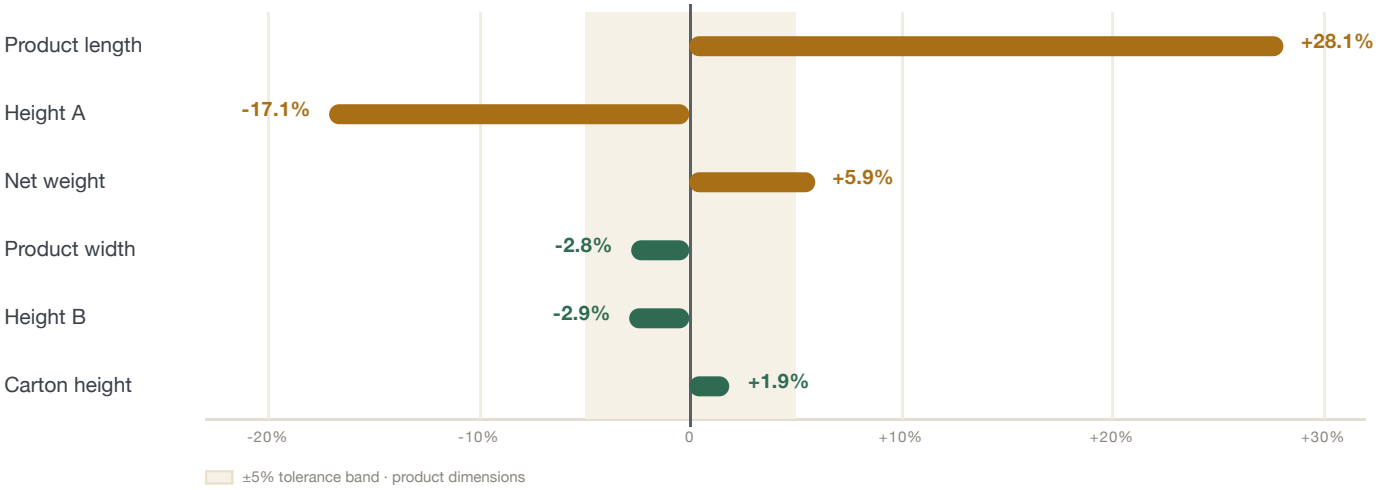
SPEC VS ACTUAL DEVIATION negative = smaller than record

ITEM	SPEC	ACTUAL	Δ	STATUS
Carton length	37.0	37.0	0.0%	IN
Carton width	37.0	36.8	-0.5%	IN
Carton height	90.0	91.7	+1.9%	IN
Gross weight	10.5	10.7	+1.9%	IN
Product length	80.0	102.5	+28.1%	OUT
Product width	90.0	87.5	-2.8%	IN
Height A	35.0	29.0	-17.1%	OUT
Height B	70.0	68.0	-2.9%	IN
Net weight	8.5	9.0	+5.9%	IN

Tolerance: carton ±8%, product ±5%. Spec values are taken from the SKU detail file; height is recorded as two positions (35 / 70 cm).

Carton size and gross weight sit inside the ±8% tolerance. Product length measures 102.5 cm against 80 cm on file (+28.1%); height A measures 29 cm against 35 cm (–17.1%).

The inspector's reading: this is a compression sofa, and the opened product is measured on a different basis than the record. The record is stale — not a production defect.

1. Update the SKU size and net weight
2. Agree one measuring method
3. Re-check on the next order
